Intel® Celeron® Processor in the 478-Pin Package

Specification Update

October 19th 2005

Document Number: 290749-025

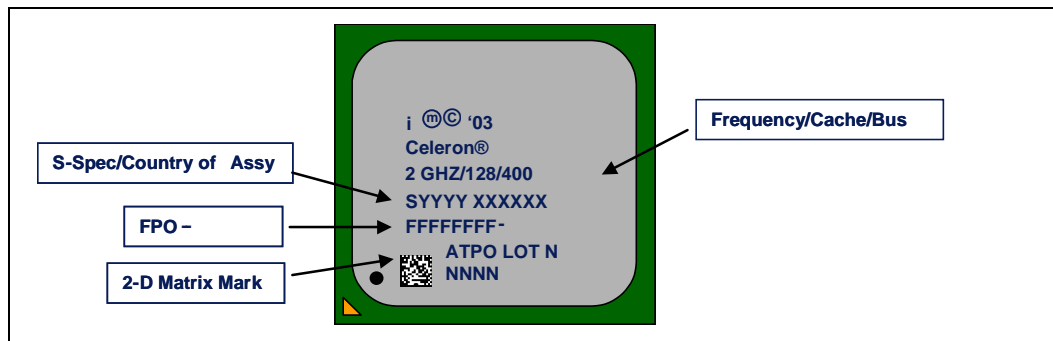
This section contains top marking information for the Intel® Celeron® processor in the 478-pin package.

Figure 1. Example Markings for the Intel® Celeron® Processor on 0.13 Micron Process and/or in the 478-Pin Package
